DEPARTMENT OF TRANSPORTATION

Contract #: 04-0120F4Cty: SF/ALA Rte: 80 PM: 13.2/13.9File #: 99.28**WELDING INSPECTION REPORT****Resident Engineer:** Casey, William**Address:** 333 Burma Road**City:** Oakland, CA 94607**Report No:** WIR-026412**Date Inspected:** 22-Sep-2011**Project Name:** SAS Superstructure**OSM Arrival Time:** 1200**Prime Contractor:** American Bridge/Fluor Enterprises, a JV**OSM Departure Time:** 2200**Contractor:** Zhenhua Port Machinery Company, Ltd (ZPMC) Chanxing Island**Location:** Shanghai, China

Bridge No: 34-0006**Component:** Traveler & Hand Rail**Summary of Items Observed:**

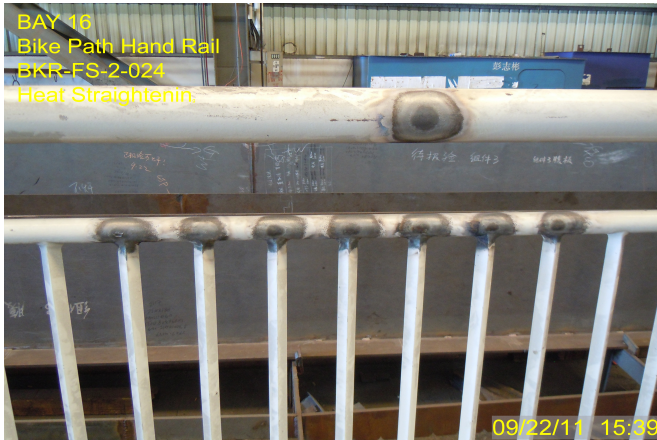
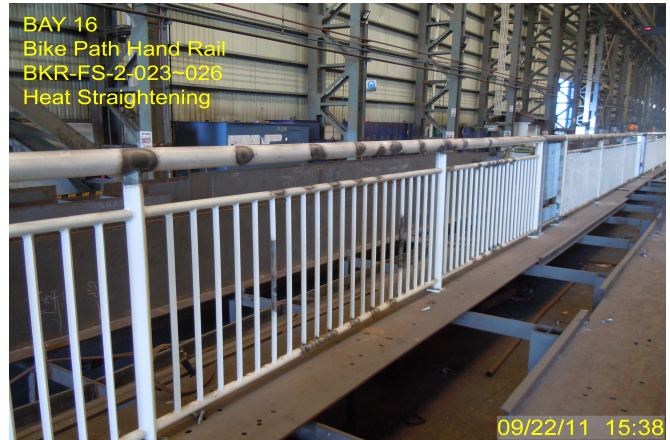
This Caltrans QA inspector received ZPMC non-destructive test (NDT) notification number 09979 from ZPMC for Bay 16. This QA inspector performed ultrasonic testing (UT) verification of welds after ZPMC had performed their UT inspection. The segment is identified as Traveler Rail. The weld designations reviewed are as follows.

Heat straightening of Hand Rail BKR-FS-2-23, BKR-FS-2-24, BKR-FS-2-25, and BKR-FS-2-26 under approved Heat Straightening procedure HSR 10418. The in process temperature was observed as 250°C. The ZPMC QC was identified as Ma Qian Li. The approved HSR procedure stated that a maximum temperature of 650°C with 1-3 numbers of applications was allowed. The distortion that was previously measured and recorded on the HSR was Maximum 5 mm.
